NATIONAL TRANSPORTATION SAFETY BOARD
Vehicle Recorder Division

Sound Spectrum Study

Group Chairman's Factual Report
By Sean Payne

Location: Baytown, Texas
Date: February 23, 2019
Aircraft: Boeing 767-375BCF, Registration N1217A
Operator: Atlas Air Cargo, Flight 3591
NTSB Number: DCA19MA086

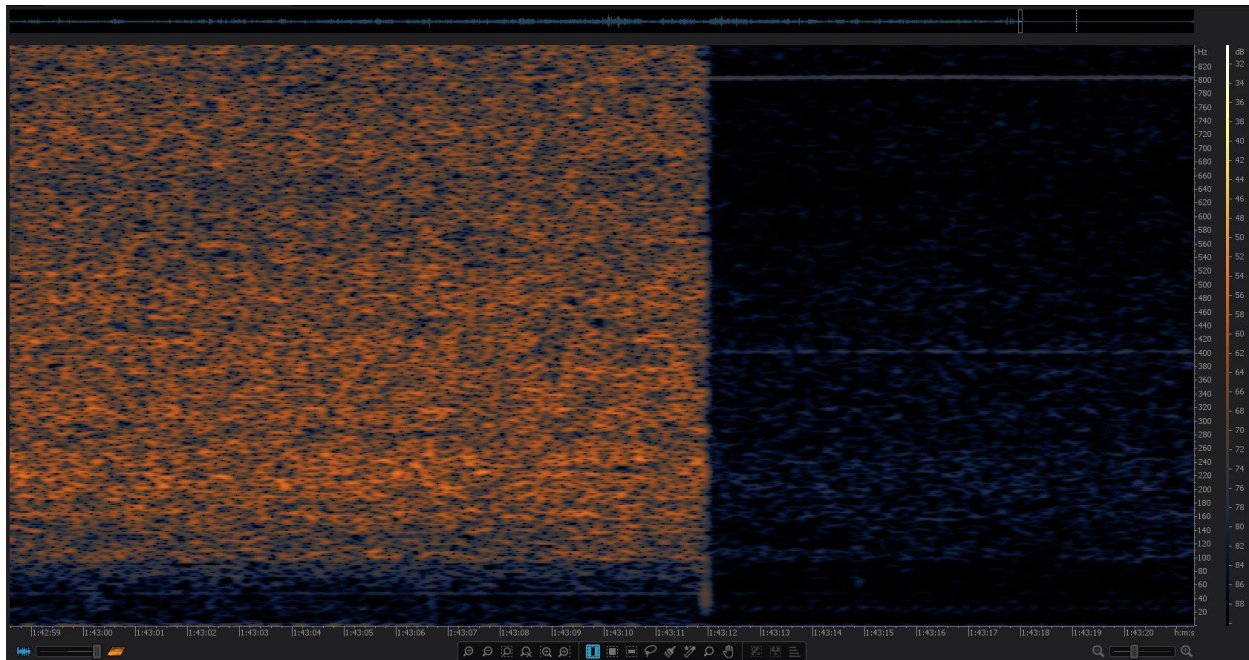
Figure 1. Region of interest examined in IzoTope RX4.

In figure 1, the signal to noise ratio has been adjusted to more clearly delineate characteristics of the recording. The adjustment clearly shows a 400 Hz power tone and associated harmonics at 800 Hz, 1600 Hz and repeating.

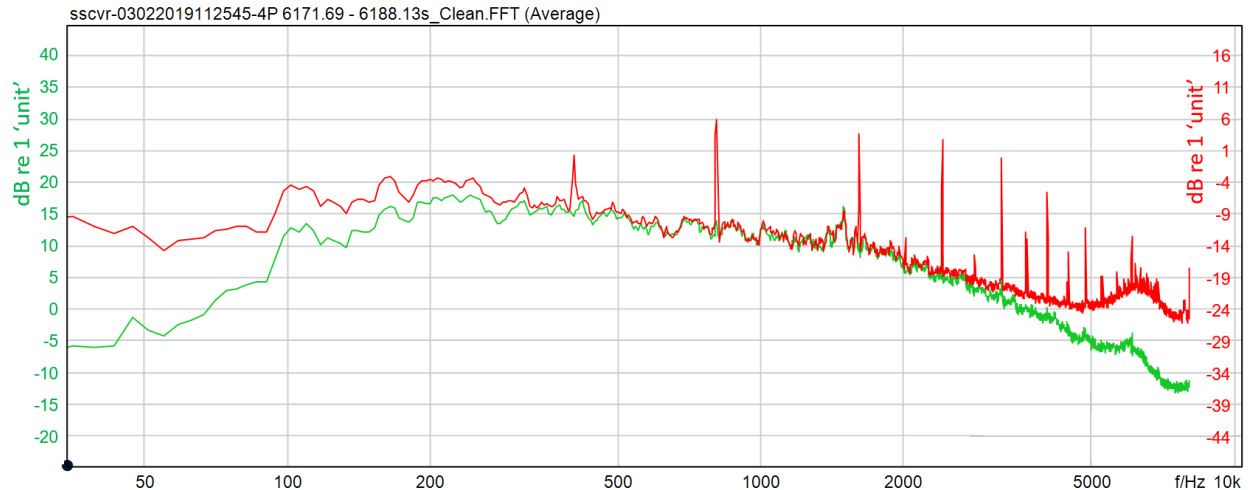
Figure 2. A FFT of 17 seconds prior to the audio level change (Channel 1 in green) and a FFT of 17 seconds post the audio level change (Channel 2 in red). The curves were plotted together to show that the background level is the same within the range of 500 Hz to 2000 Hz. However, there is a 24 dB shift between the curves. The red curve shows noise floor influence below 500 Hz and above 2000 Hz.

In figure 2, channel 2 is shown (red) as having frequency values at 400 Hz, 800 Hz, 1600 Hz and repeating at higher frequency levels. Channel 1 (green) shows a “cleaner” signal with limited frequency values than those observed in channel 2.

Additionally, a root mean square (RMS) value was measured for a time interval 10 seconds before and a time interval 10 seconds after the signal change. The RMS value was 22.2 dB higher prior to the signal change than the RMS measured after the signal change.

As a result of this change in decibel level, dynamic range is lost, resulting in the loss of some audio data.

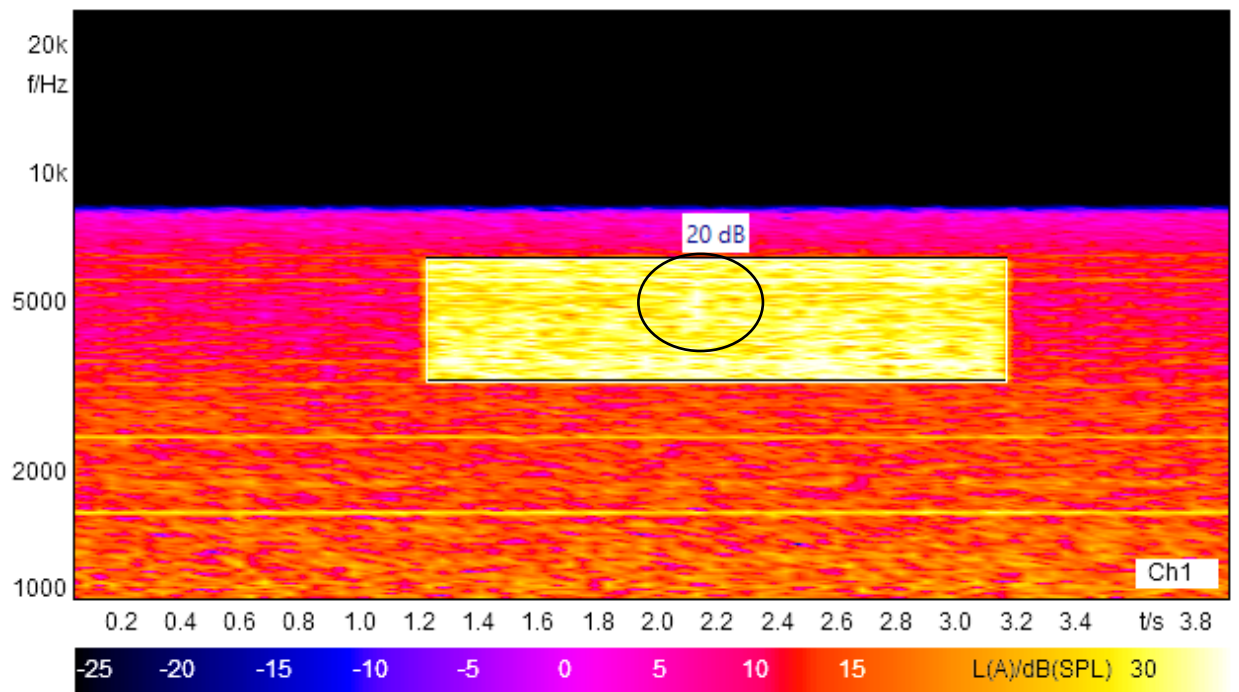
Figure 3 is a screen capture of sound spectrum information around the time of the clicking noise. A circle annotates an area of sound energy believed to be associated with the

clicking noise. Using digital filtering, it is possible with the human ear to hear the clicking noise.

Figure 3. Sound energy potentially associated with the clicking noise detected at 12:38:31.1 CST.

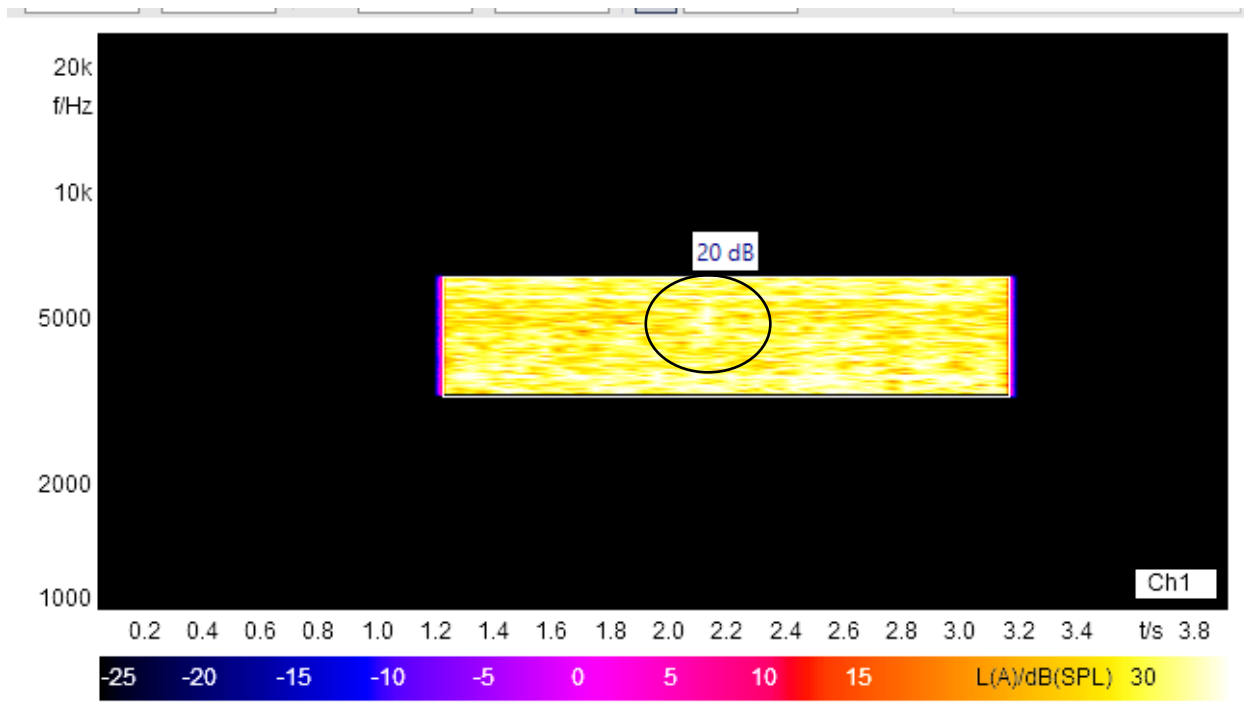
Figure 4. Sound energy isolated at an approximate 5000 Hz correlating to the clicking noise at 12:38:31.1 CST. The clicking sound was audible with all other sound energy information removed.

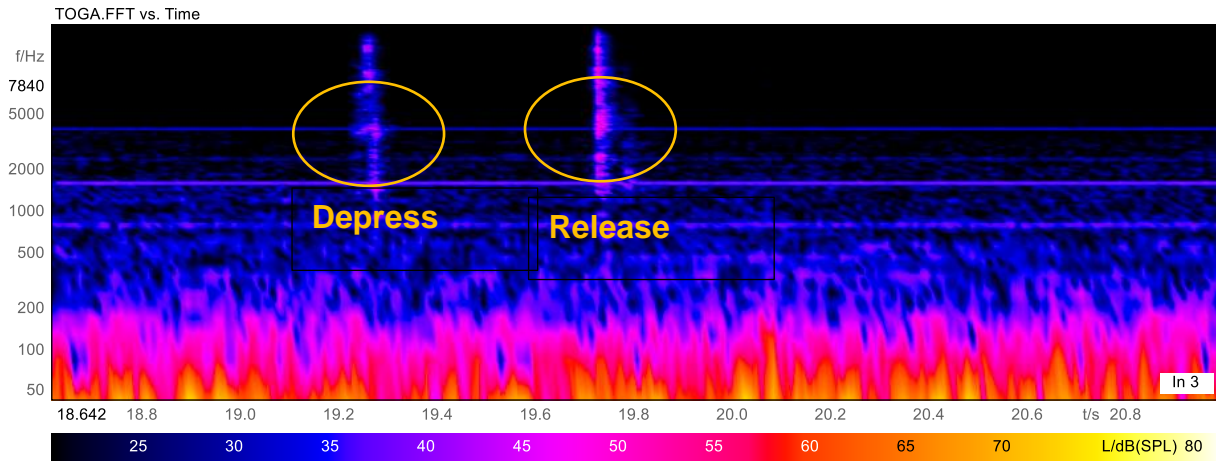
Figure 5 is a screen capture of sound spectrum information associated with an exemplar recording of a go around button (GA) activation of a 767 freighter while on the ground. The exemplar information revealed the sound associated with the exemplar GA button depress is two distinct sounds which can be described as a double action click. One sound is associated with the depression of the switch and the second sound is associated with the release of the switch. The sound of release of the GA switch has a higher sound energy content. These noises carry through a frequency range of approximately 1kHz to 10 kHz, however, these sounds have an elevated characteristic of sound energy around 5000 Hz. Circles placed on figure 5 point to a regions of elevated sound energy at 5000 Hz associated with an exemplar GA button depress and release cycle.

Figure 5. TOGA actuation on a 767 freighter on ground. Microphone is a B&K 4192 held at CAM panel location.

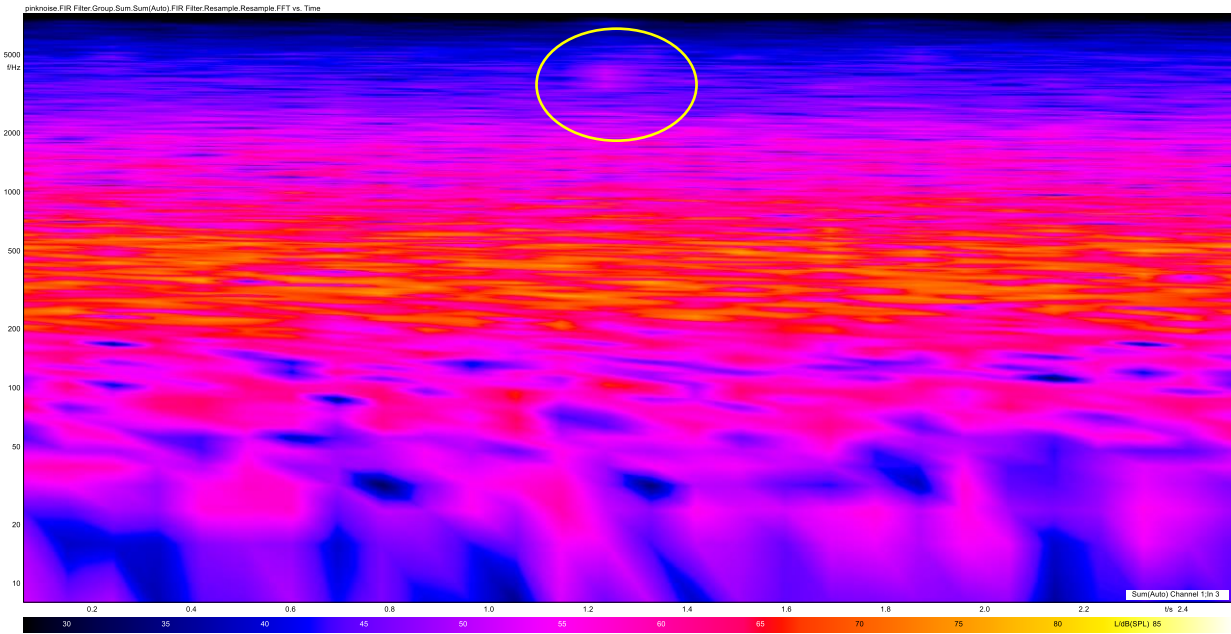
Figure 6. An exemplar recording of a GA button activation on a 767, mixed with the sounds of an exemplar 767 aircraft descending from 5,000 feet. The energy of the GA clicking sound is circled in the above plot. The energy was around 5,000 Hz.

The clicking sound at 12:38:31.1 CST shares a similar characteristic of an exemplar GA button activation (elevated sound energy at 5000 Hz). The dual clicking nature of the exemplar recording was not detected in this region, and may not have been possible to detect the dual nature of the exemplar noise for the recording to capture due to the aircraft being in flight with an additional 24 dB decrease in sound energy. Since the release portion of the GA click contains more sound energy, the clicking noise on the accident recording could potentially be associated with the release of the GA button.

In summary, the clicking noise shares some characteristics of the exemplar GA button activation, specifically the release portion of an exemplar GA button activation, however, it cannot be conclusively determined if it is the same sound due to the degraded quality of the CAM channel recording at the time of the sound detection (12:38:31.1 CST).

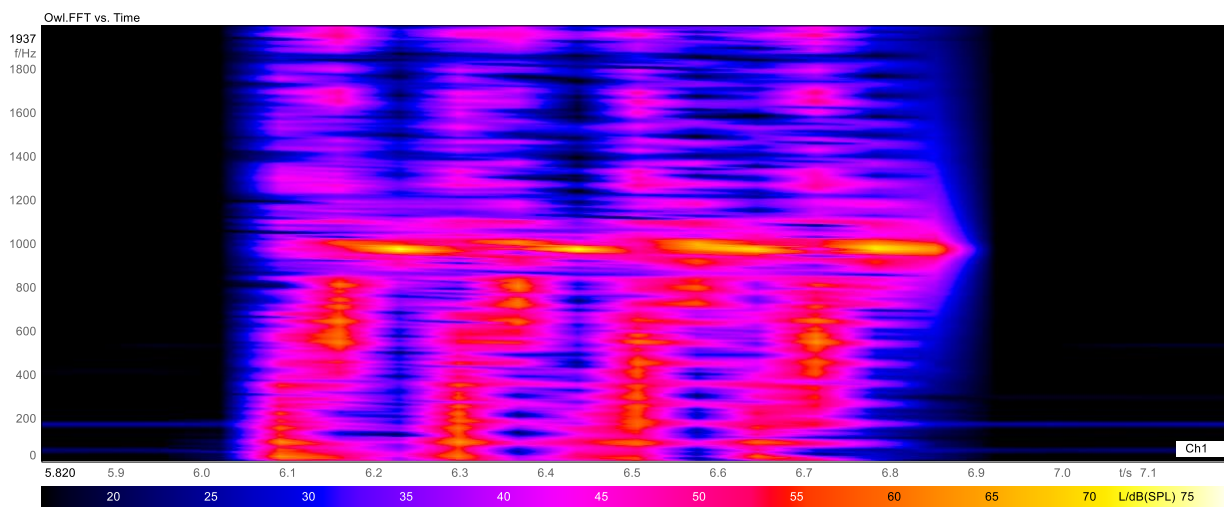
Figure 7 is an exemplar recording of the “owl” beeper aural warning. According to Boeing’s Flight Crew Operations Manual for this aircraft (FCOM) which covers system descriptions for aural alerts, *“Beeper is used for all system alert caution messages. The beeper consists of a tone that sounds four times in a second. The beeper automatically silences after one series of four beeps.”* The exemplar recording of the beeper shows the level at 1,000 Hz.

Figure 7. An exemplar recording of the “Owl” beeper aural warning.

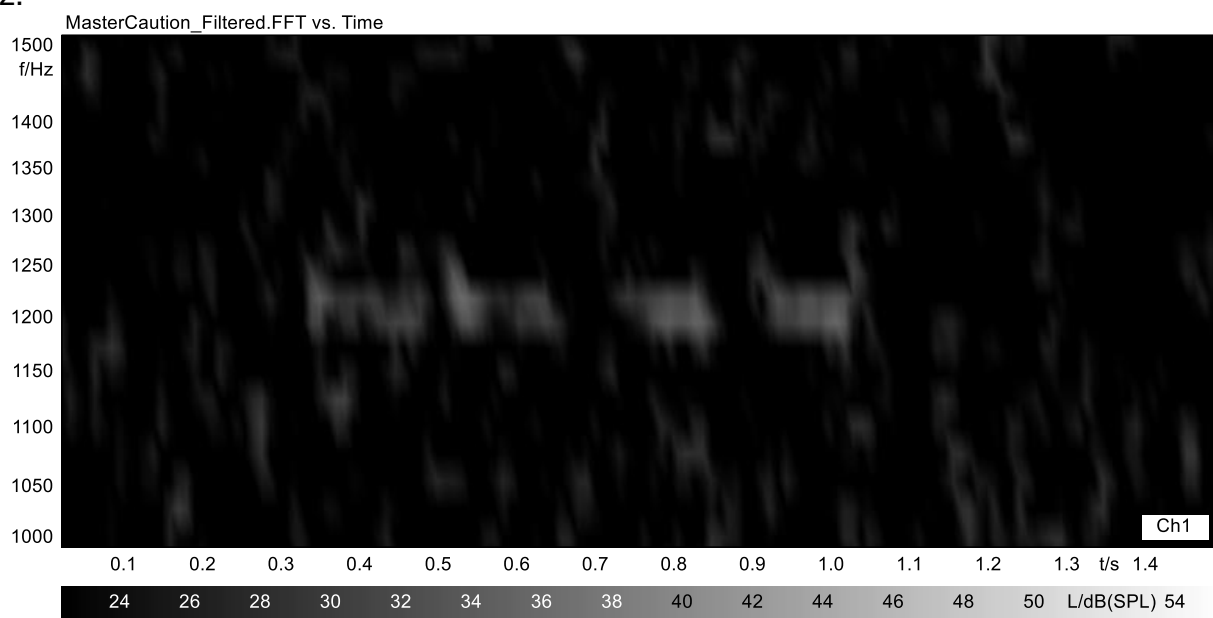
Figure 8 is the “four beeping” sound from the accident recording at 12:38:40.3 CST. During the accident flight, a four beeping sound was registered at approximately 1,200 Hz.

Figure 8. Four beeping sound from the accident recording at 12:38:40.3 CST.

The four tones are consistent with the ‘owl’ beeper aural warning. According to Boeing, this warning is “four repetitive tone bursts each increasing in frequency through the first portion of the burst after which, the frequency shall remain constant until the end of the burst. The burst shall start at approximately 20 Hz and sweep to approximately 1000 Hz over the first quarter of the burst and shall remain at 1000 Hz for the remainder of the burst period.” The owl does not call out a specific fixed value, as it’s ‘approximately 1000 Hz’. According to Boeing, 20% tolerance is an acceptable probability for this system. The frequency is inversely proportional to the voltage applied to the timer; therefore, the voltage timer impacts the owl ending frequency.

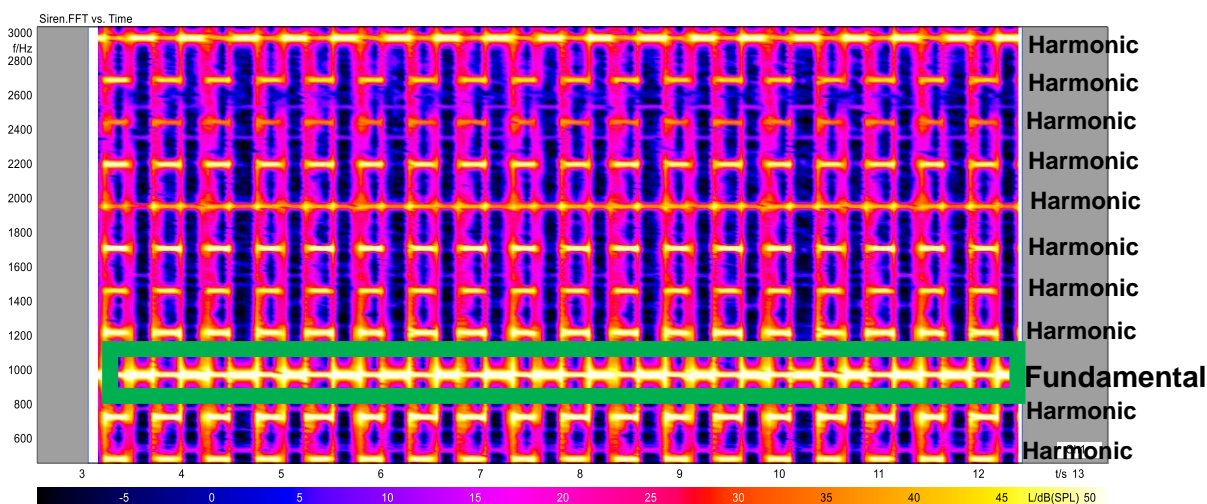
Figure 9 is an exemplar recording of the “Siren.” According to Boeing’s FCOM for this aircraft, “Siren – Used to annunciate cabin altitude, configuration, autopilot disconnect and overspeed warning alerts. The siren consists of alternating high and low tones.”

Figure 9. An sound spectrum of an exemplar recording of the “Siren” and its harmonics. The fundamental frequency is highlighted at 1,000 within the green box.

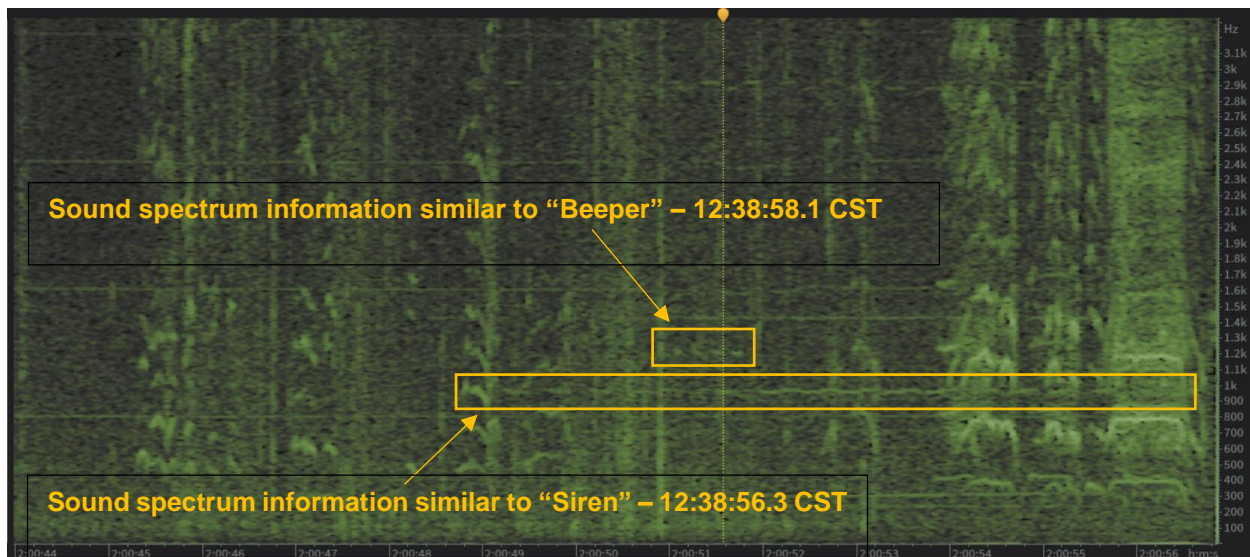
Starting at 12:38:56.3 CST, a 1,000 Hz frequency is detected in the spectrogram from the accident recording. No obvious harmonics were detected. The spectrogram for this sound has a slight alternating high and low frequency characteristics. Figure 10 is the spectrogram of the accident recording at this time.

Figure 10. A sound spectrogram of the end of the recording which contains a component similar to the aircraft’s “Siren.” The four beeping sound (beeper) at 12:38:58.1 CST is also noted.

The group that transcribed the CVR then described a sound “similar to Siren” at 12:38:58.9 CST. When referencing figure 10, the sound spectrum shows a sound profile that carried through from 12:38:56.3 CST. When reviewing the information shown in figure 10, it is likely the beeper began at 12:38:56.3 CST. It is unclear if the beeper ceased prior to the termination of the recording as other sound information is obscuring the signal in the final moments of the recording.

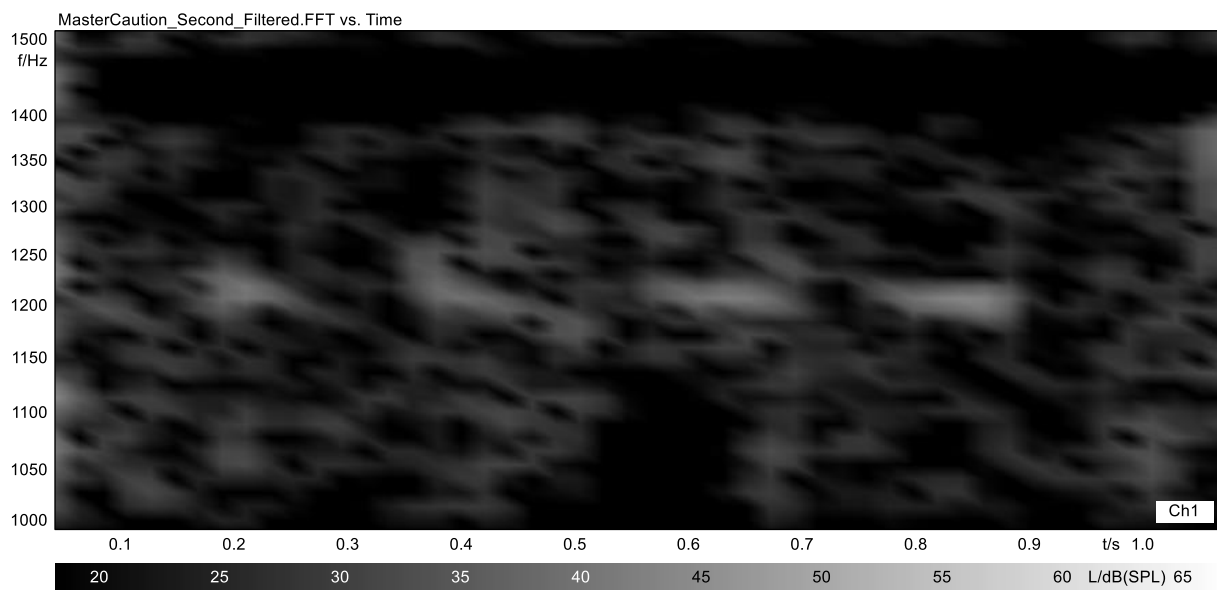
The same four beeping sound detected at 12:38:40.3 CST was detected again at 12:38:58.1 CST. The characteristics of this beeping sound are the same as described in that section. This sound is likely to be the aircraft’s “beeper.” This area is shown in figure 11.

Figure 11. “Sound of quick series of four beeps at 1200 Hz” at 12:38:58.1 CST
